NRL Report 6293
AFML-TR-64-408

Electron Microscope Fracture Examination to Characterize and Identify Modes of Fracture

C. D. BEACHEM

*Physical Metallurgy Branch
Metallurgy Division*

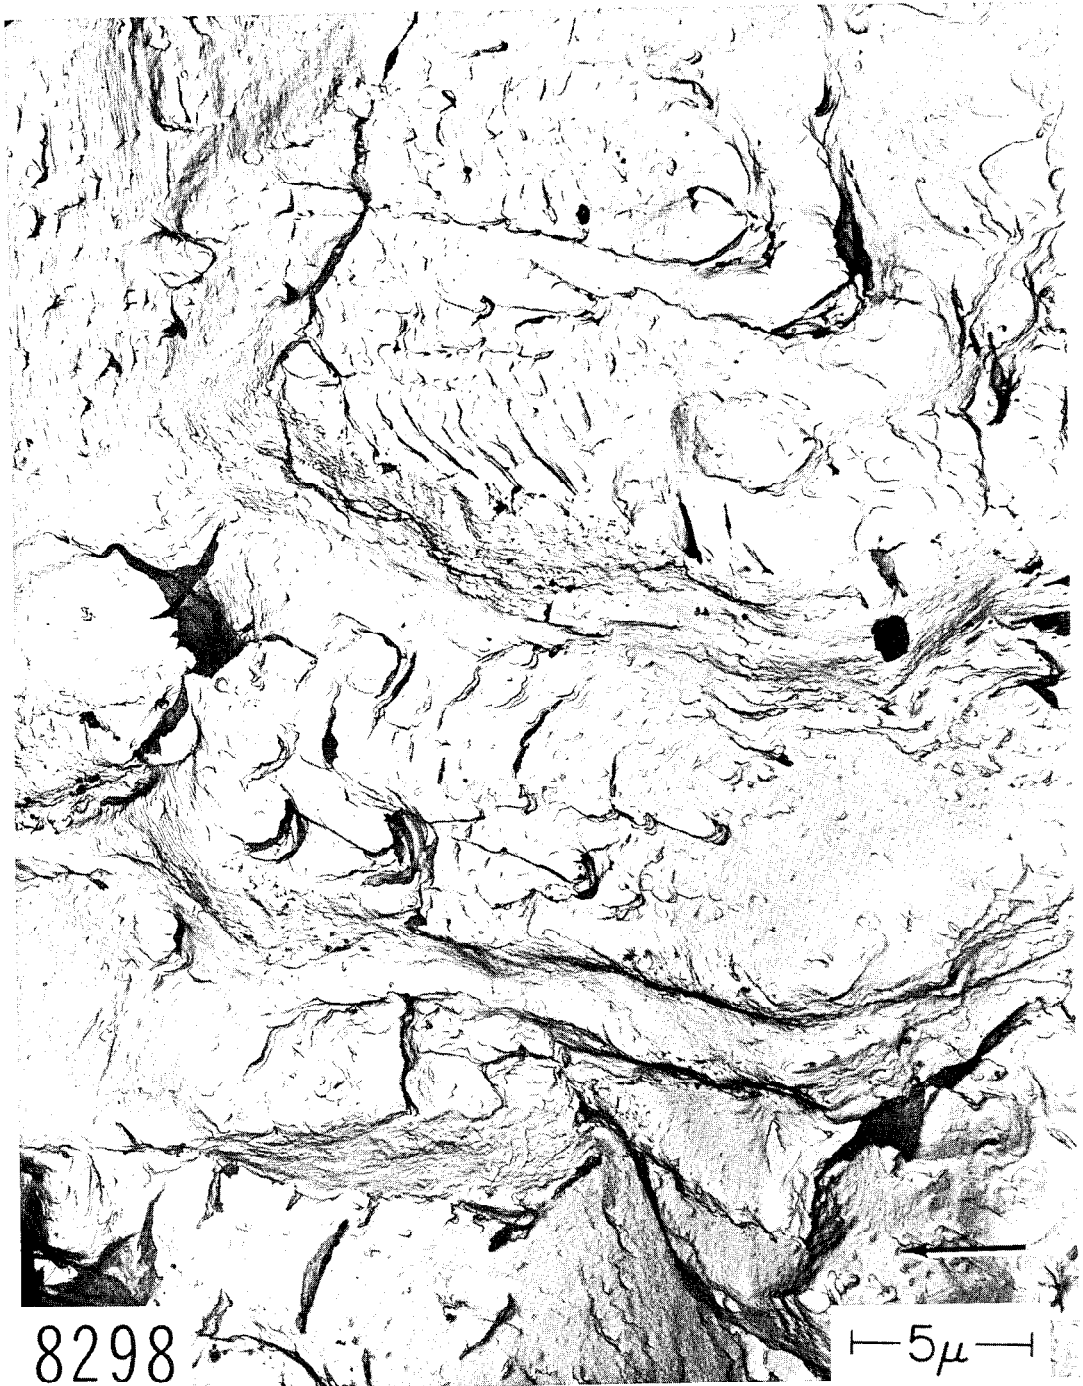
Fig. 10 - Tension-tension plane-strain fatigue markings in the WR fracture direction in 2020 T651 aluminum alloy. Cellulose acetate-carbon replication technique. Palladium shadowed. 6000X.

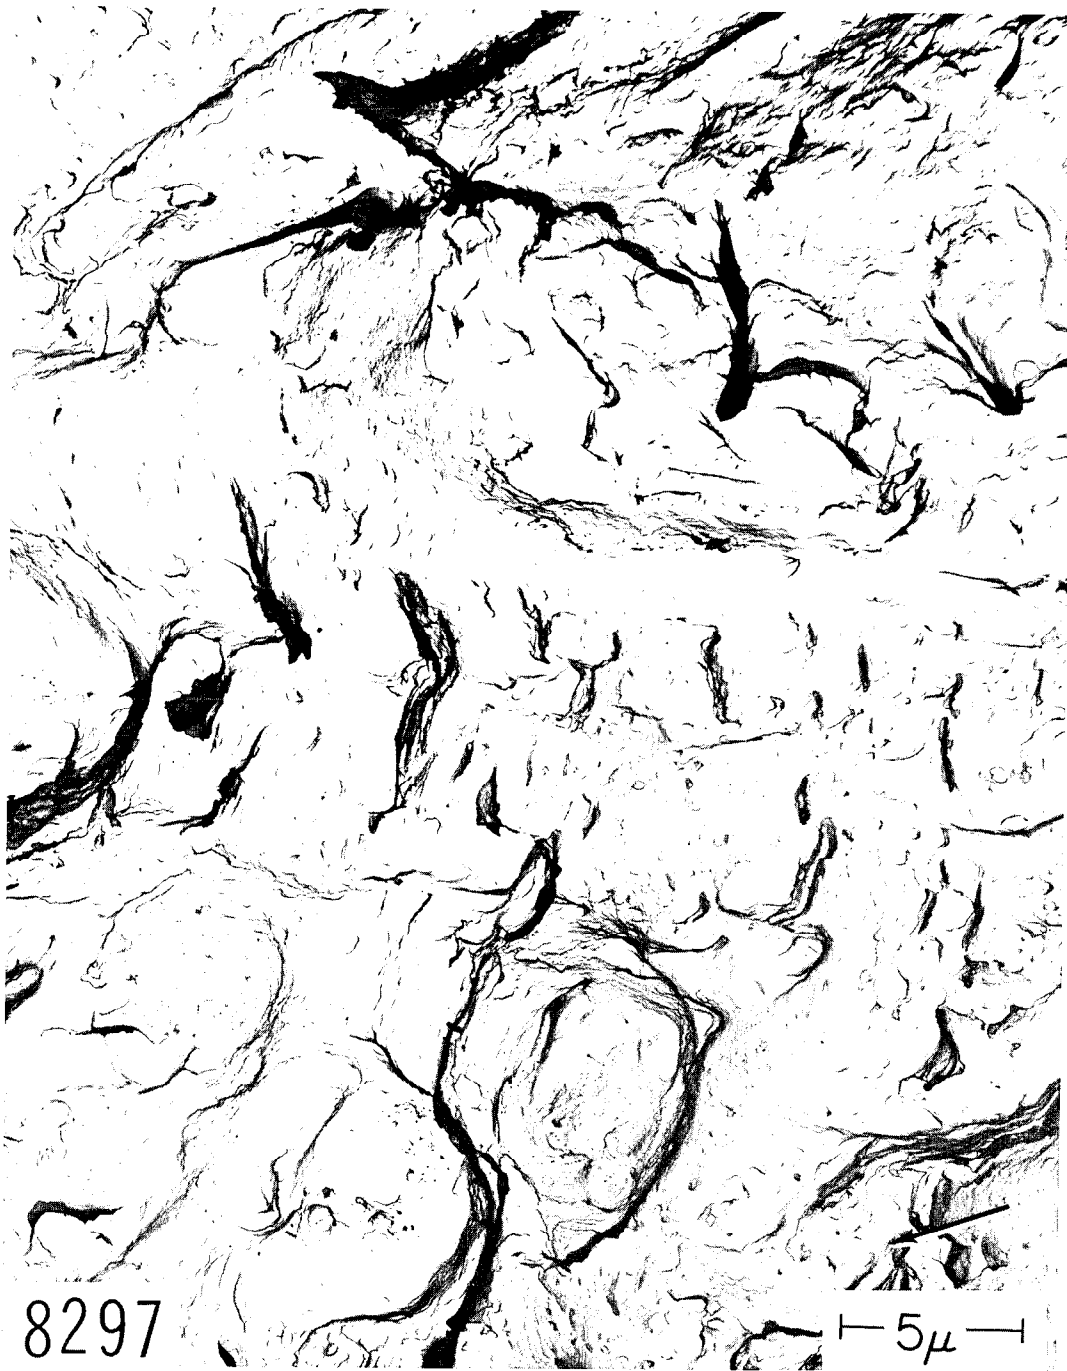
Fig. 11 - Tension-tension plane-strain fatigue markings in the WR fracture direction in 2020 T651 aluminum alloy. Cellulose acetate-carbon replication technique. Palladium shadowed. 6000X.

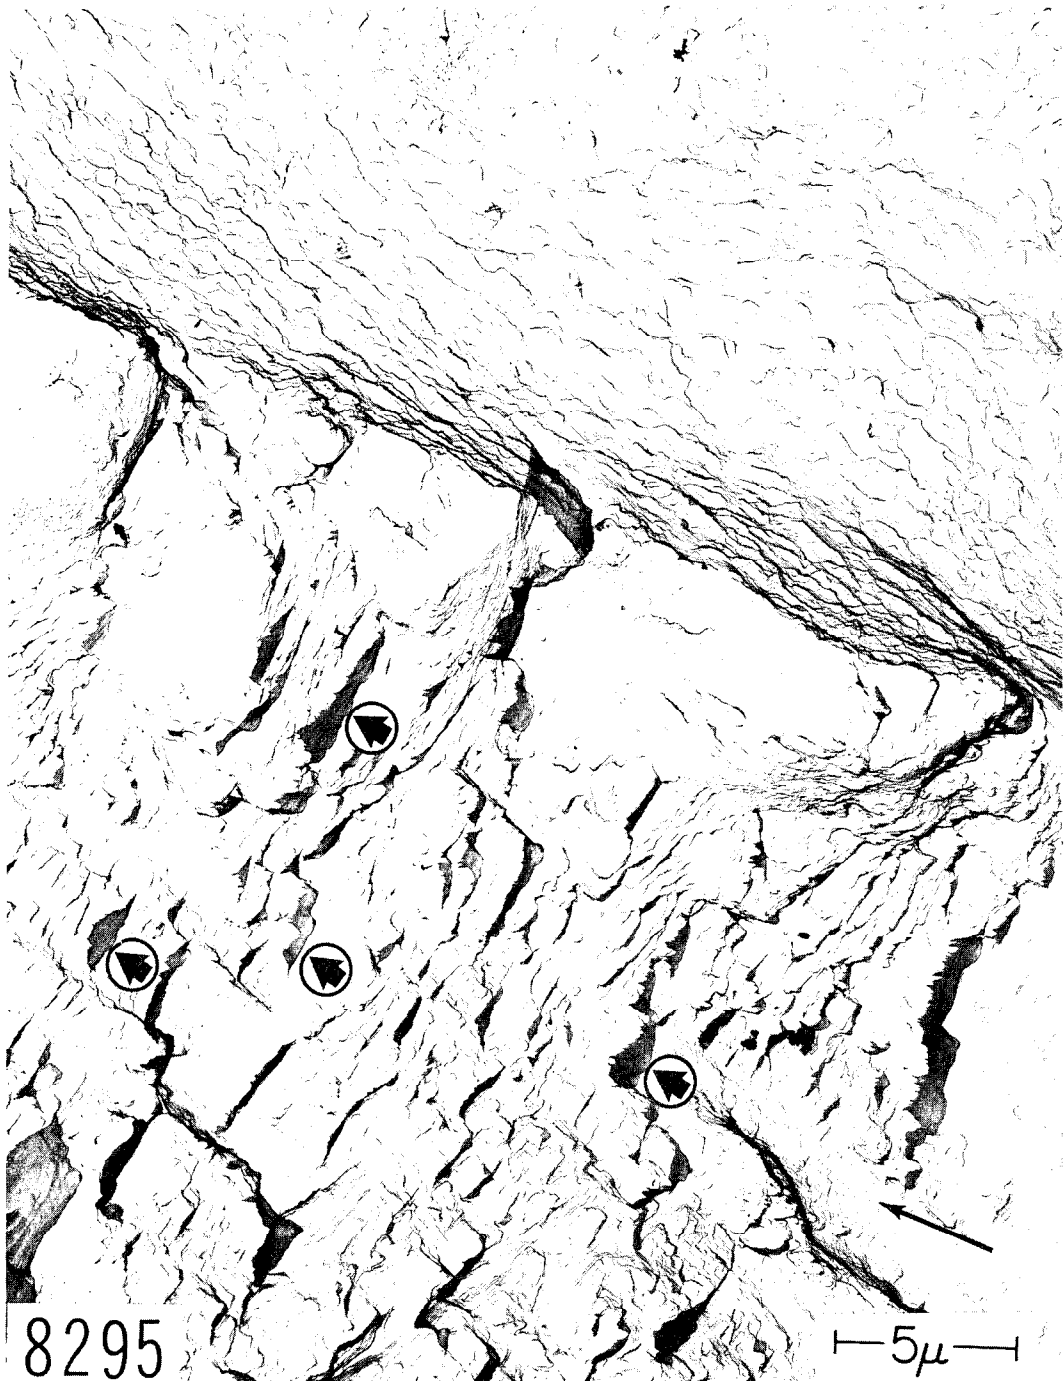
Fig. 12 - Tension-tension plane-strain fatigue markings in the WR fracture direction in 2020 T651 aluminum alloy. Short deep cracks are indicated by arrows. Cellulose acetate-carbon replication technique. Palladium shadowed. 6000X.

plate specimens. The specimens were 3/4 in. thick, 2 in. wide, and 5 in. long. The fatigue cracks were propagated under tension-tension loading (2000 pounds to 5000 pounds) at 3600 cycles per minute. The specimens were broken after precracking by impact loading. One specimen was tested in the TW direction.* The impact energies for both specimens were about 15 foot pounds. Plane strain fracture surfaces are shown in Figs. 1-3. Though these were taken from the RW specimen, they are characteristic of the fracture surface features of the plane strain surfaces in both specimens. Figure 1 shows typical dimples and some scraping artifacts (2). Figure 2 shows what is probably the effect of a banded structure. Figure 3 shows some of the flat regions (arrows) that were often associated with dimples. The fatigue markings for the RW direction are shown in Figs. 4-6. Figures 4 and 5 show that the fatigue markings often were mixed with tear dimples. Figures 5 and 6 show that striations often had tongue-shaped cracks (arrows) along parts of their lengths. Figures 7-12 show the fatigue markings found on the WR fracture surface. In Figs. 7 and 8, the fatigue markings are largely of the usual type (expected in aluminum alloys). However, Figs. 9-12 show, in increasing order, some markings that are not nicely shaped, smoothly curved groups of striations, but consist of short deep cracks as evidenced by thin films of carbon standing in relief on the replica surface (arrows in Fig. 12). Figure 12 also shows a patch of dimples in the upper portion.

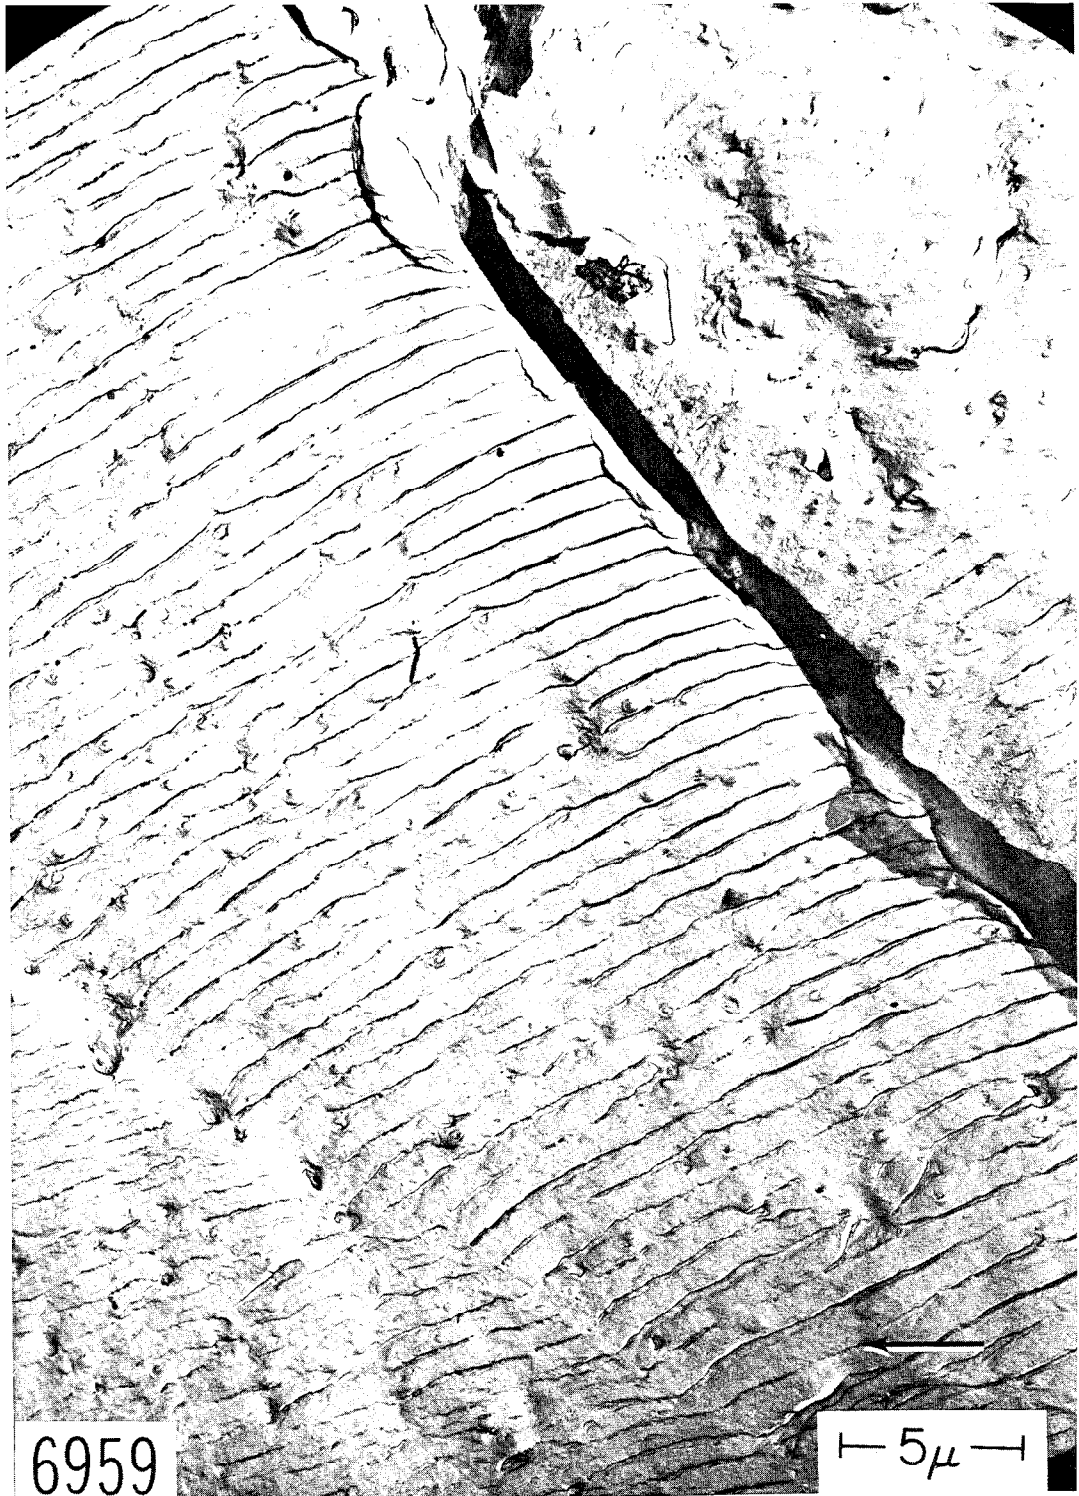
Fig. 13 - Tension-tension plane-strain RW fatigue markings in 2024 T851 aluminum alloy plate. Cellulose acetate-carbon replication technique. Palladium shadowed. 6000X.

Specimens from three orientations (RW, WR, TR) were cut from a 5-in. thick plate of 2024 T851. The specimens were prepared and tested in the Mechanics Division and were of the short Single Edge Notched (SEN) type - 1/4 in. \times 1-1/2 in. \times 3.3 in. The fracture toughness values were 46.2 KSI $\sqrt{\text{in.}}$ for the RW direction, 37.5 KSI $\sqrt{\text{in.}}$ for the WR direction, and 23.2 KSI $\sqrt{\text{in.}}$ for the TR direction. The fatigue precracks were made in bending on a lathe and no records of the stresses were made. Figures 13-24 show the influence of orientation on the appearance of the fatigue markings. Figures 13-16 show the RW markings to be, in general, evenly spaced, gently curved striations arranged in groups that are separated by steps (black near-vertical lines in Fig. 15).

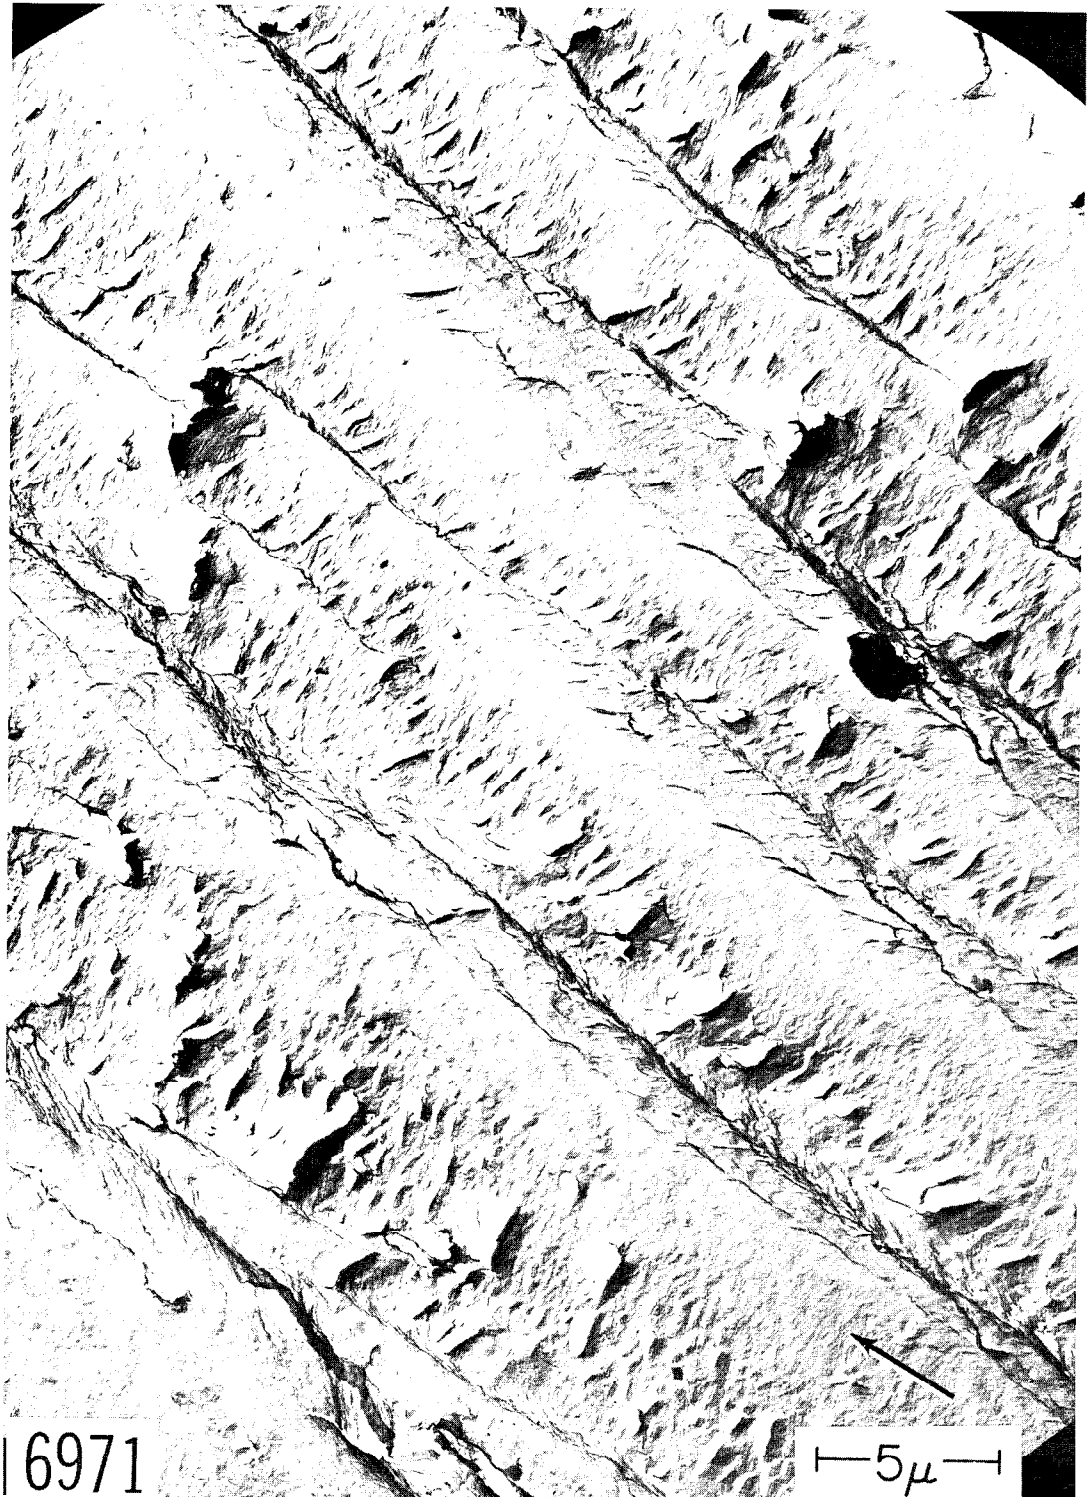
Fig. 19 - Tension-tension plane-strain WR fatigue markings in 2024 T851 aluminum alloy plate. Cellulose acetate-carbon replication technique. Palladium shadowed. 6000X.

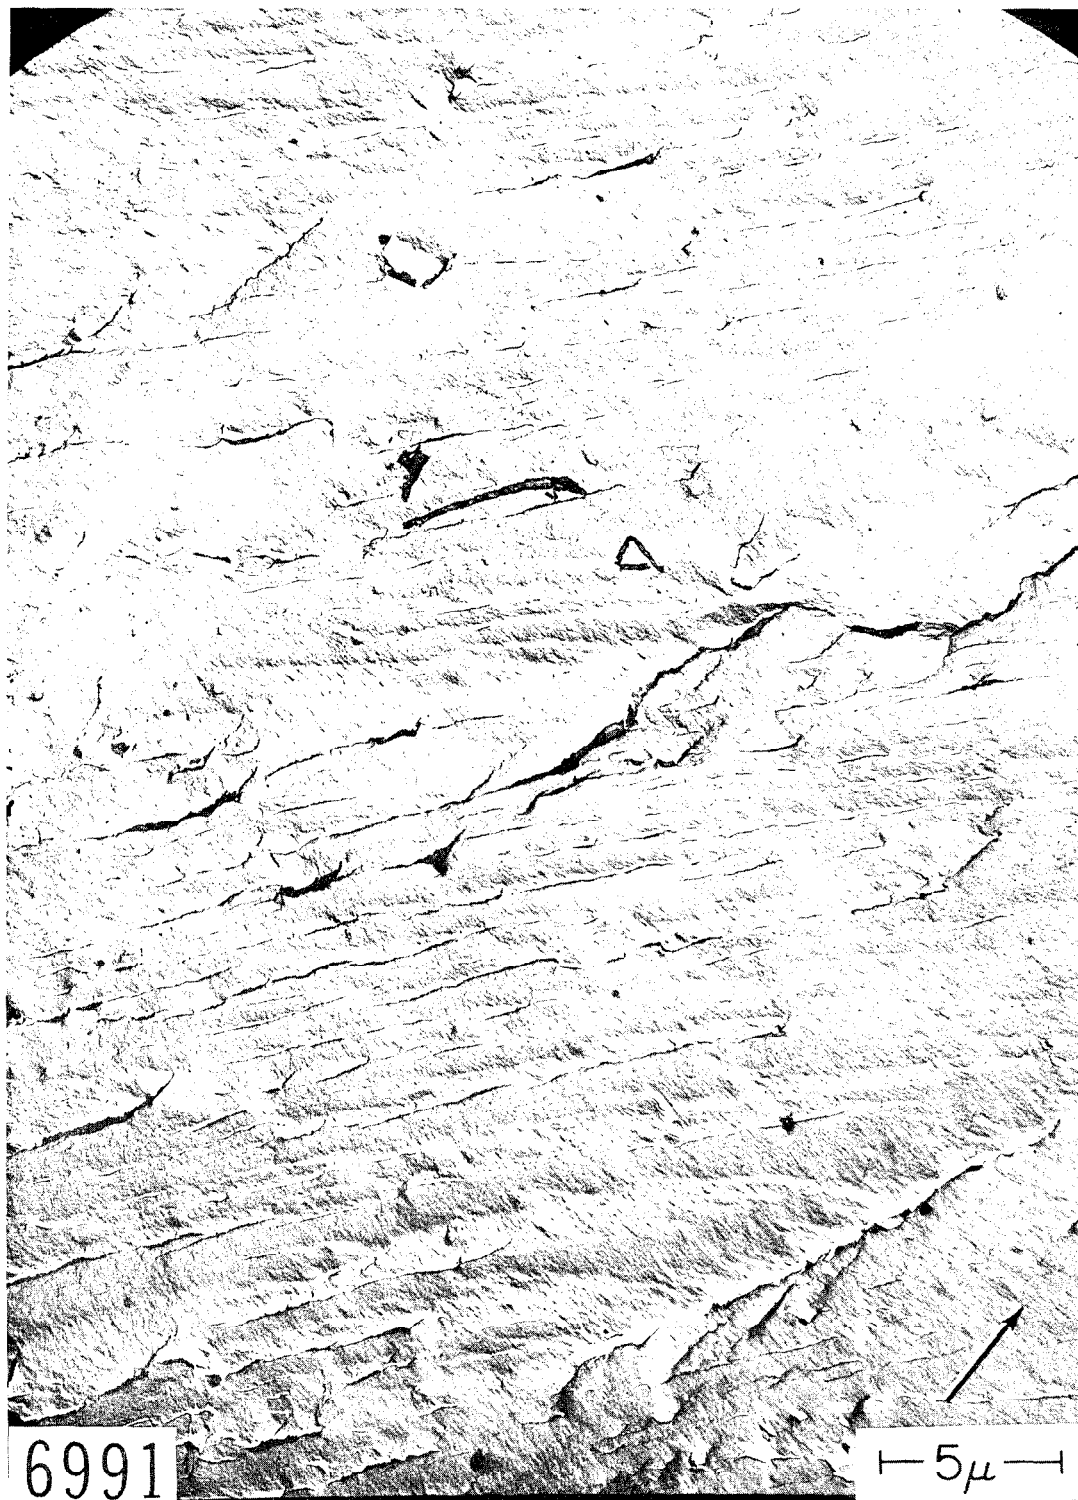
Fig. 20 - Tension-tension plane-strain WR fatigue markings in 2024 T851 aluminum alloy plate. Cellulose acetate-carbon replication technique. Palladium shadowed. 6000X.

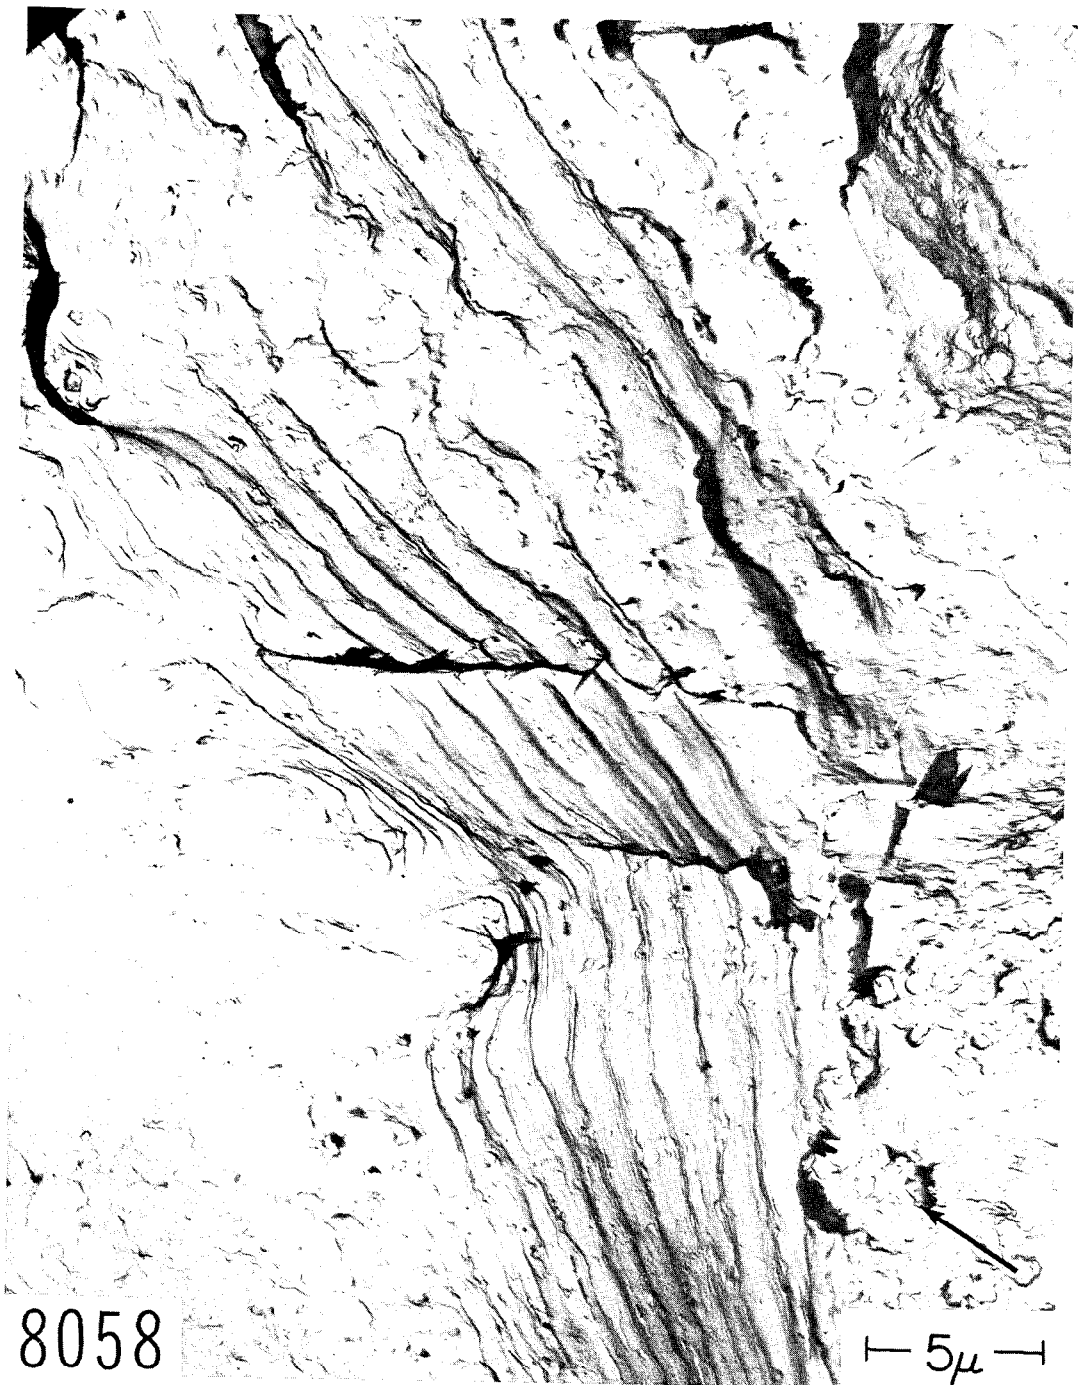
Fig. 25 - Tension-compression high-strain RW fatigue markings in 2024 T4 aluminum alloy. Cellulose acetate-carbon replication technique. Palladium shadowed. 6000X.

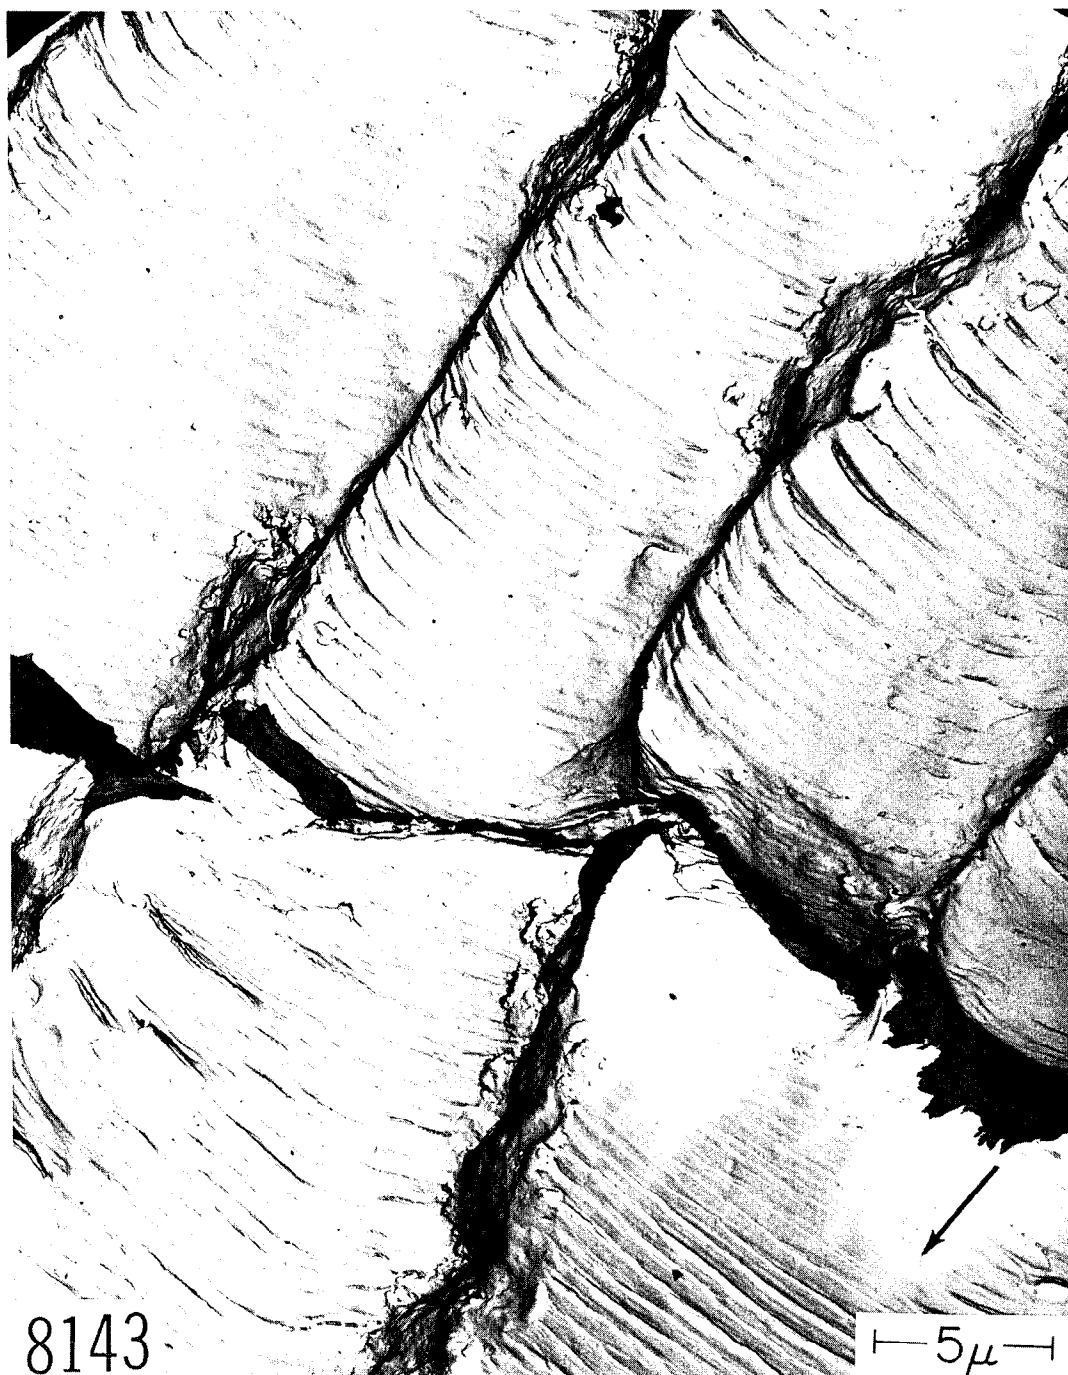
Fig. 30 - Plane-strain tension-compression high-strain room temperature fatigue markings in a crack propagated in the WR direction in a plate of 6061 T651 aluminum alloy. Cellulose acetate-carbon replication technique. Palladium shadowed. 6000X.

direction. The fatigue surface features are shown in Figs. 29-31. The groups of striations in these fractographs are characteristic of those found in most aluminum alloys. Large and small dimples characterize the flat monotonic fracture surface shown in Figs. 32 and 33.

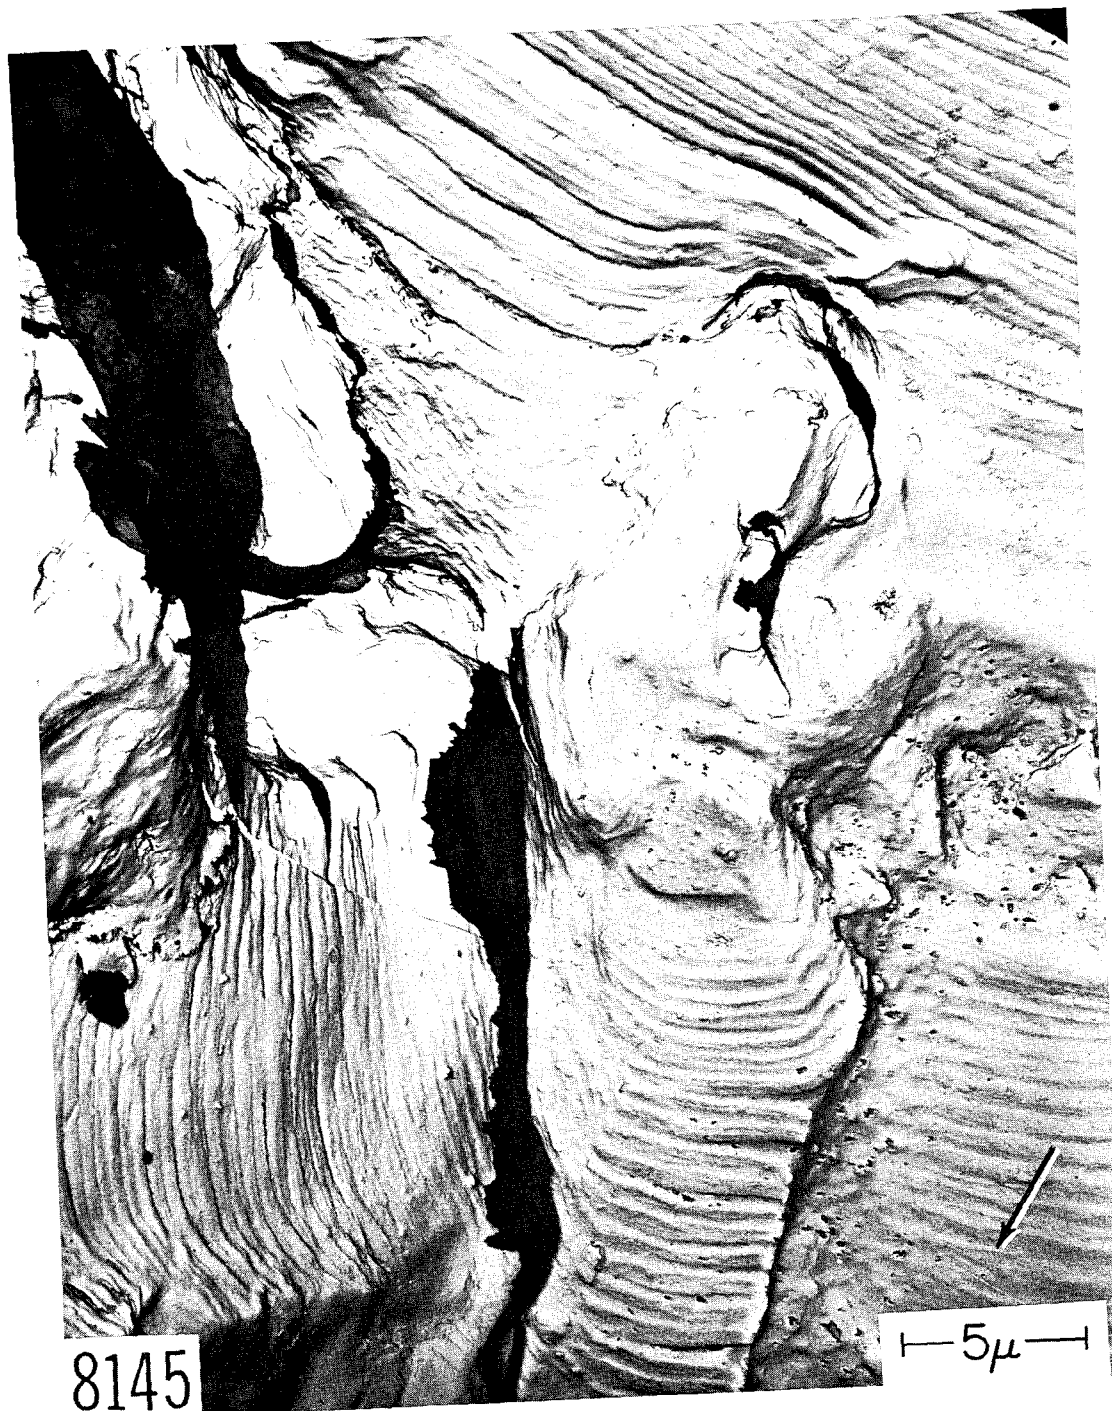
Fig. 31 - Plane-strain tension-compression high-strain room temperature fatigue markings in a crack propagated in the WR direction in a plate of 6061 T541 aluminum alloy. Cellulose acetate-carbon replication technique. Palladium shadowed. 6000X.

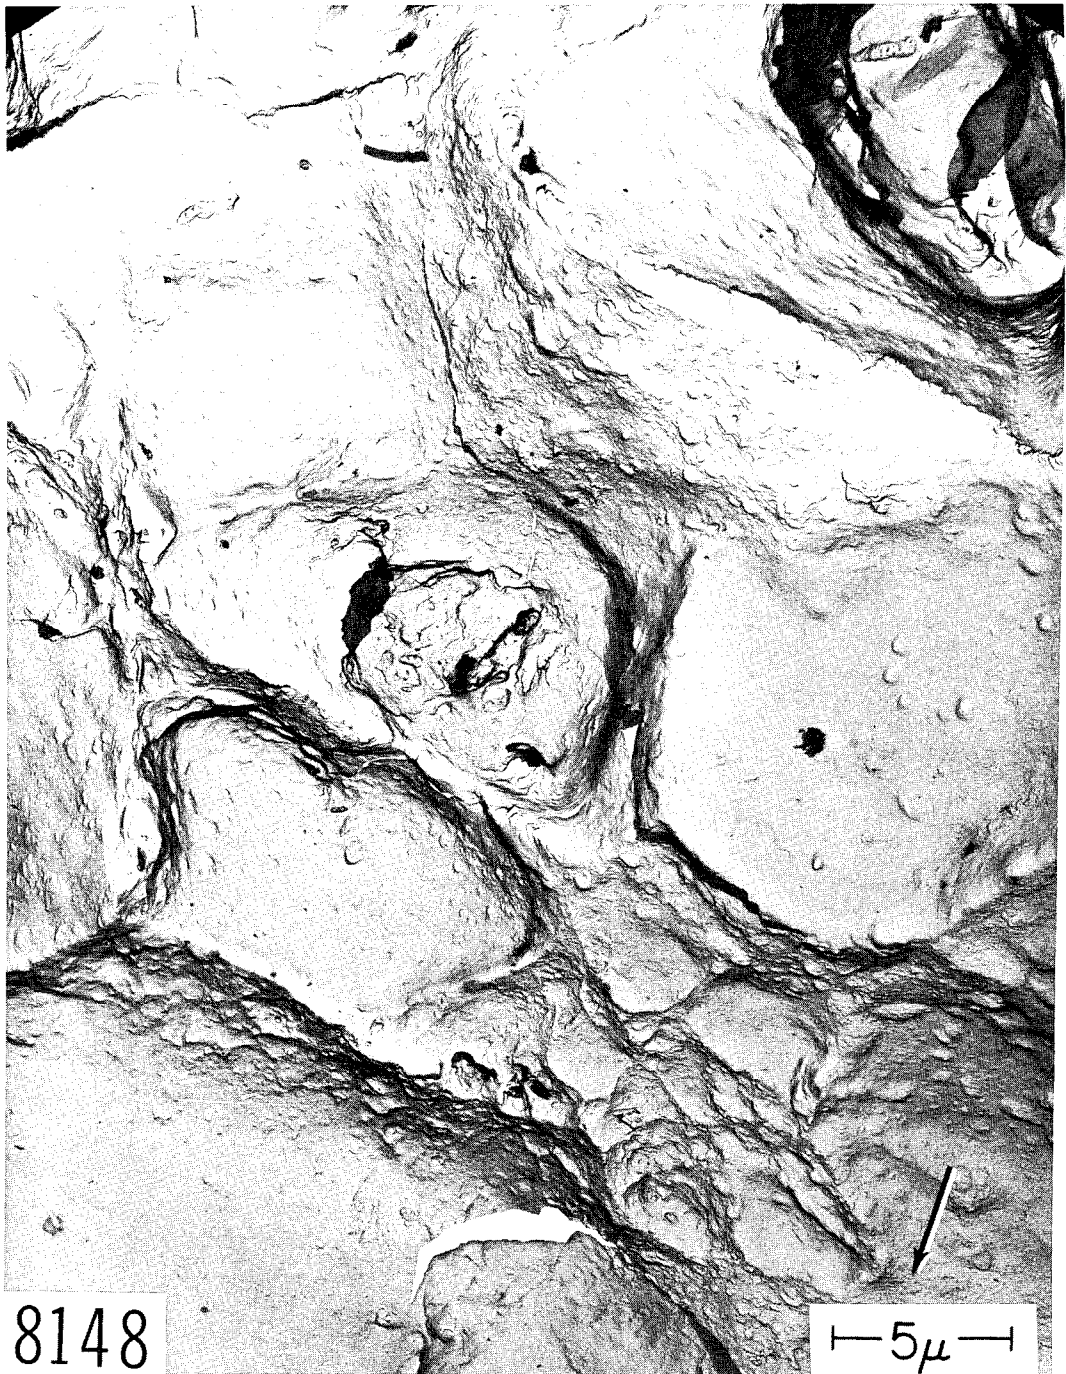
Fig. 33 - Room temperature plane-strain monotonic fracture in 6061 T651 aluminum alloy. Cellulose acetate-carbon replication technique. 6000X.

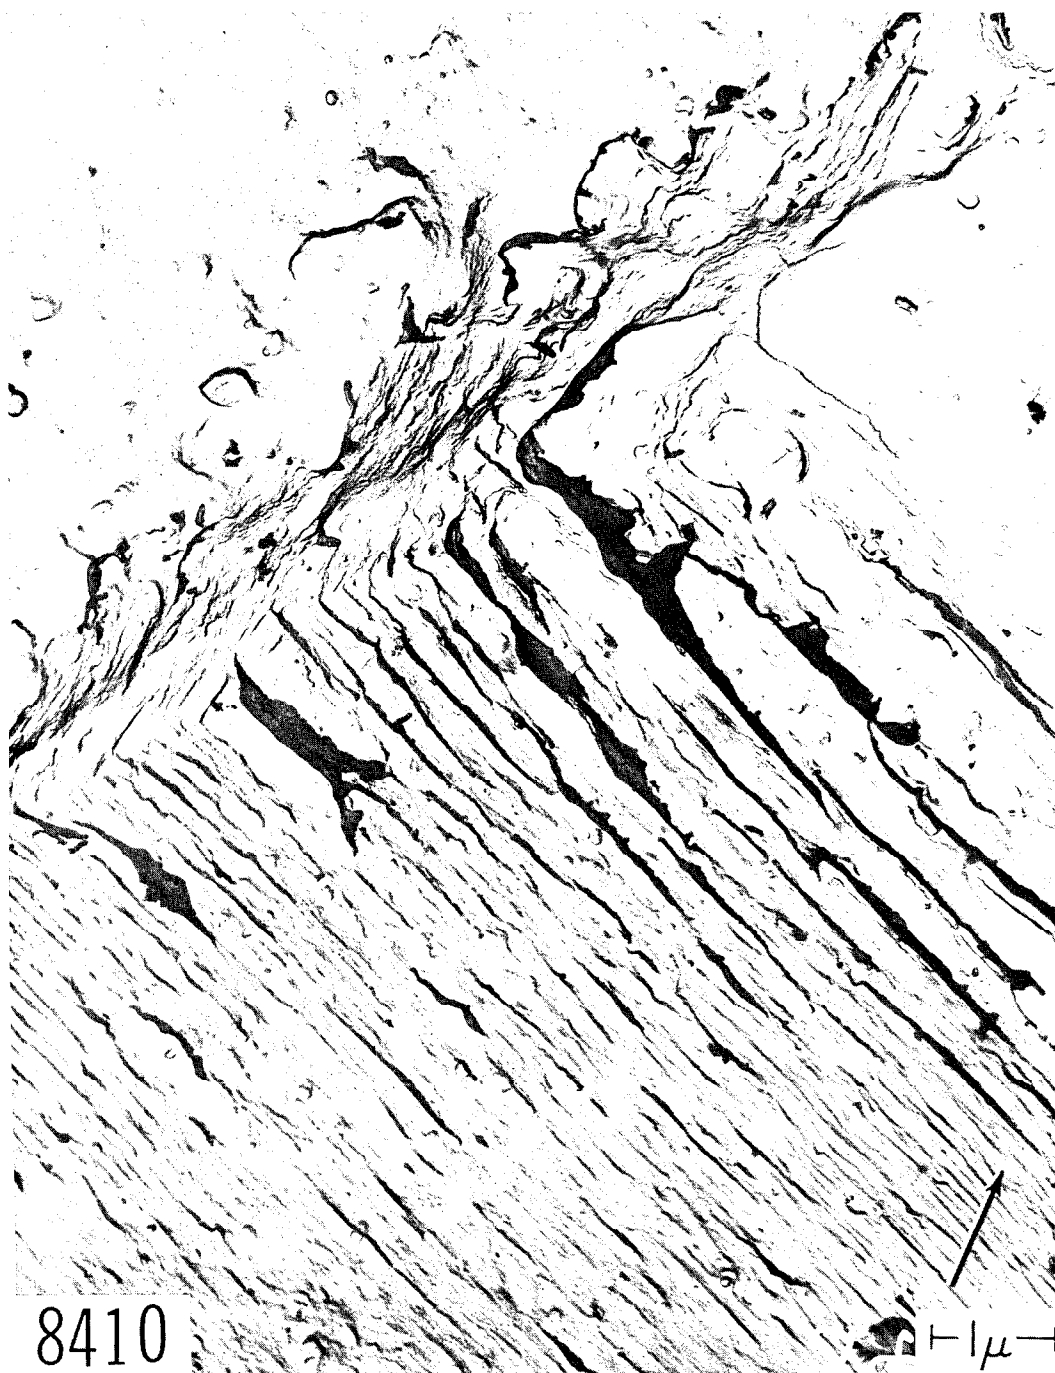
Fig. 34 - Room temperature tension-tension fatigue markings in 7178 T6 aluminum alloy. Cellulose acetate-carbon replication technique. Palladium shadowed. 21,000X.

A short single-edge notch specimen of 7178 T6 aluminum alloy was fatigue pre-cracked and broken with an indicated toughness K_{Ic} of $21.3 \text{ KSI } \sqrt{\text{in.}}$. The fatigue markings are shown in Figs. 34 and 35. Dimples in the plane strain (monotonic) fracture surface are shown in Figs. 36-38.

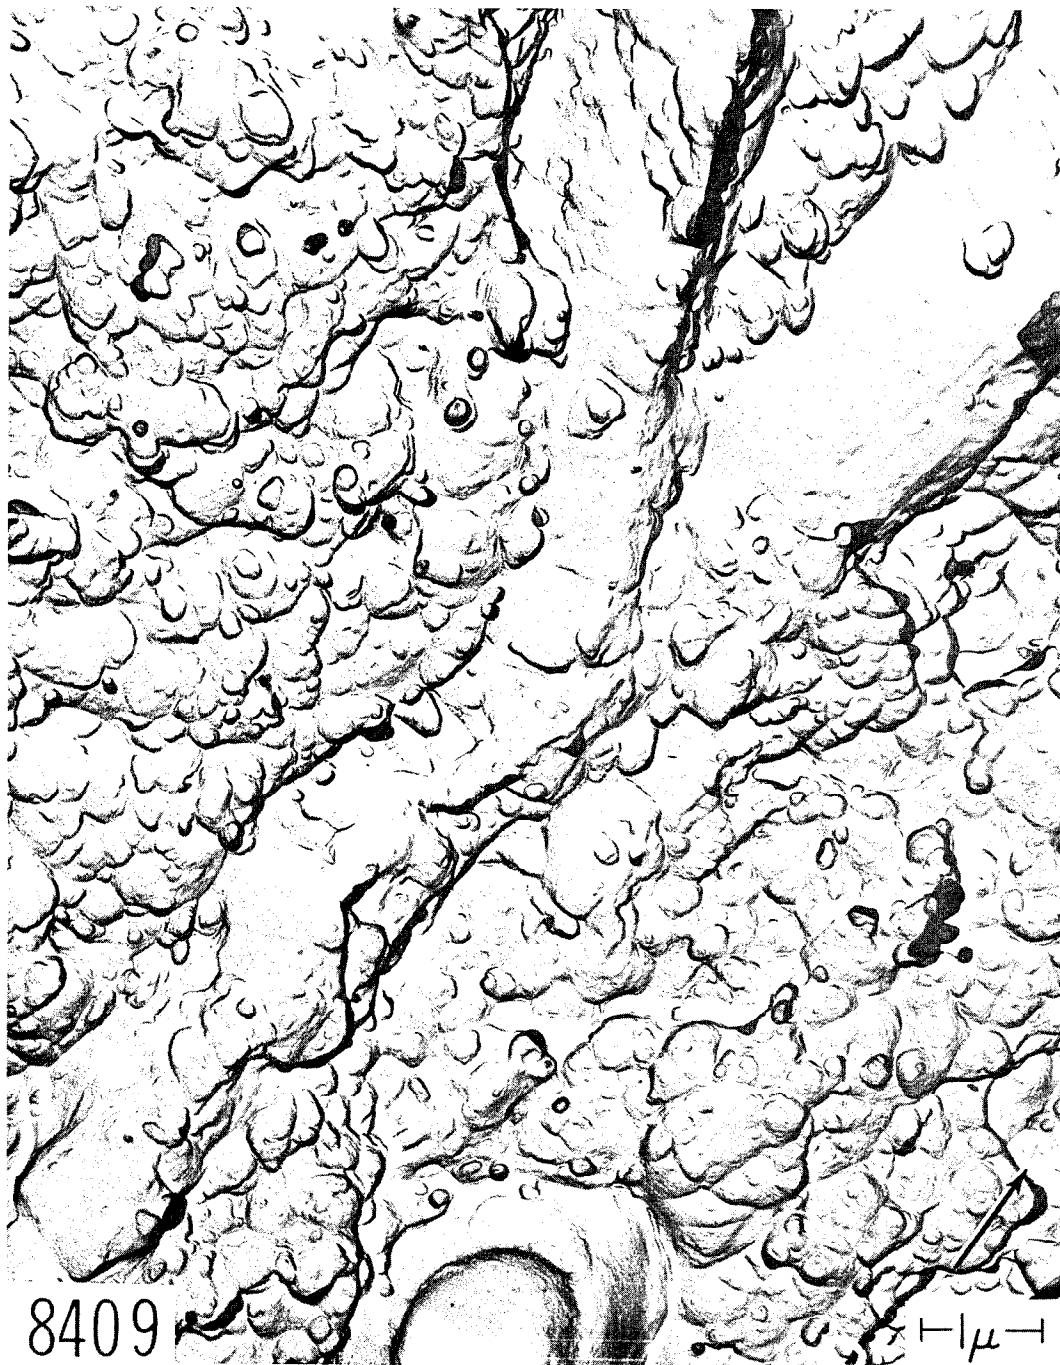
Fig. 36 - Room temperature monotonic plane-strain fracture surface in 7178 T6 aluminum alloy. Cellulose acetate-carbon replication technique. 21,000X.

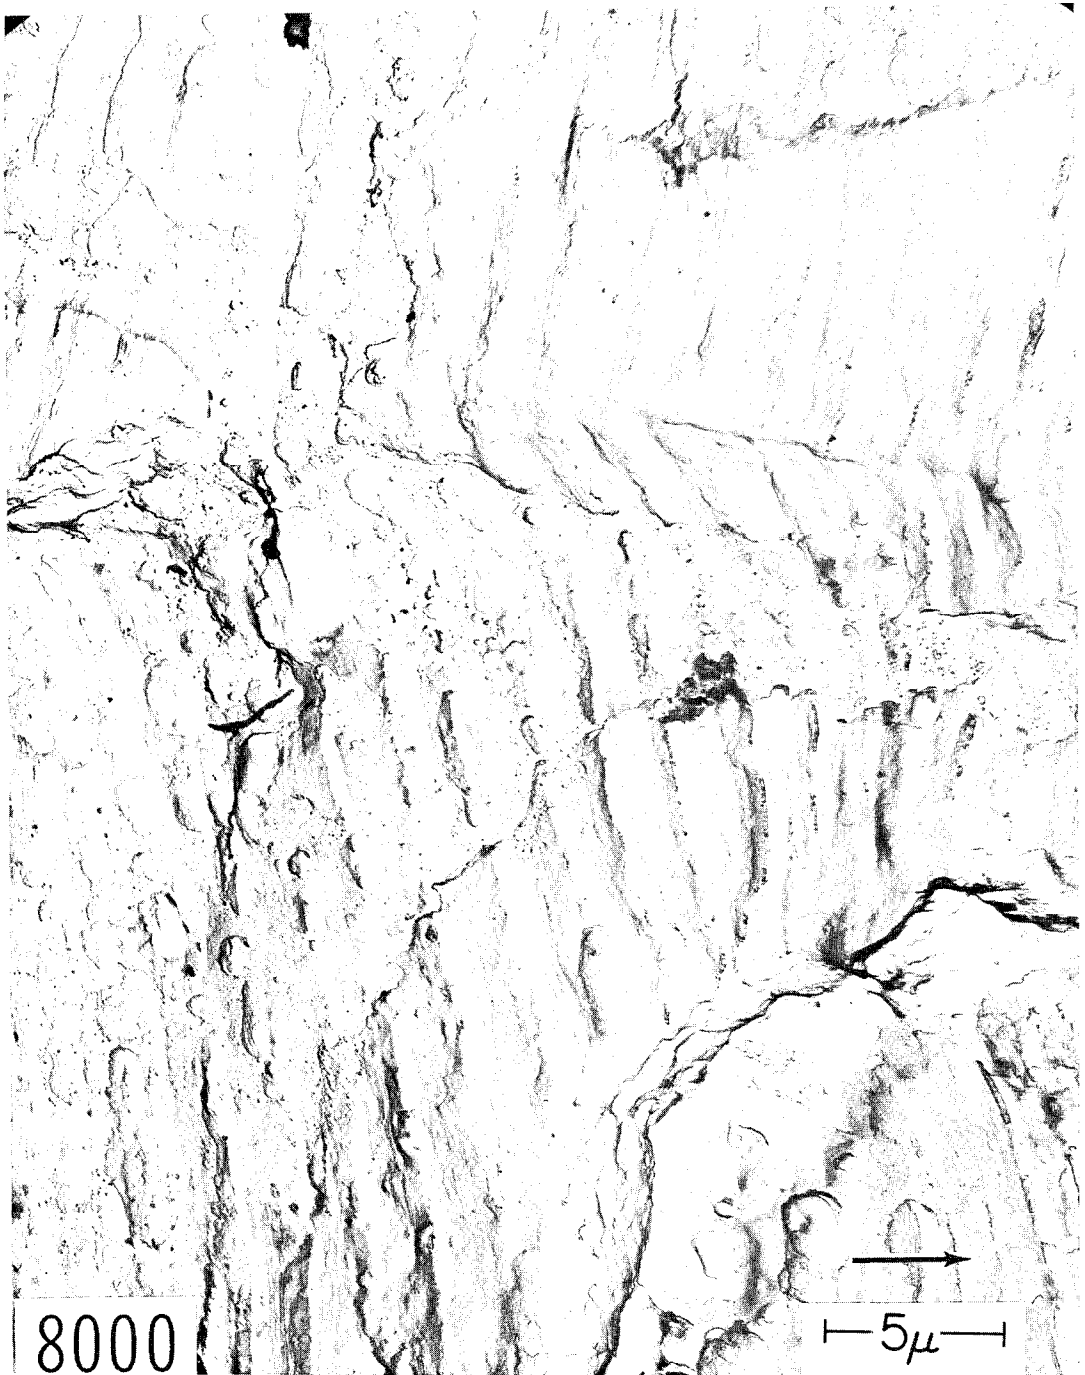
Fig. 41 - Room temperature tension-compression high-strain fatigue markings in 7075 T6 aluminum alloy plate. Cellulose acetate-carbon replication technique. Palladium shadowed. 6000X.

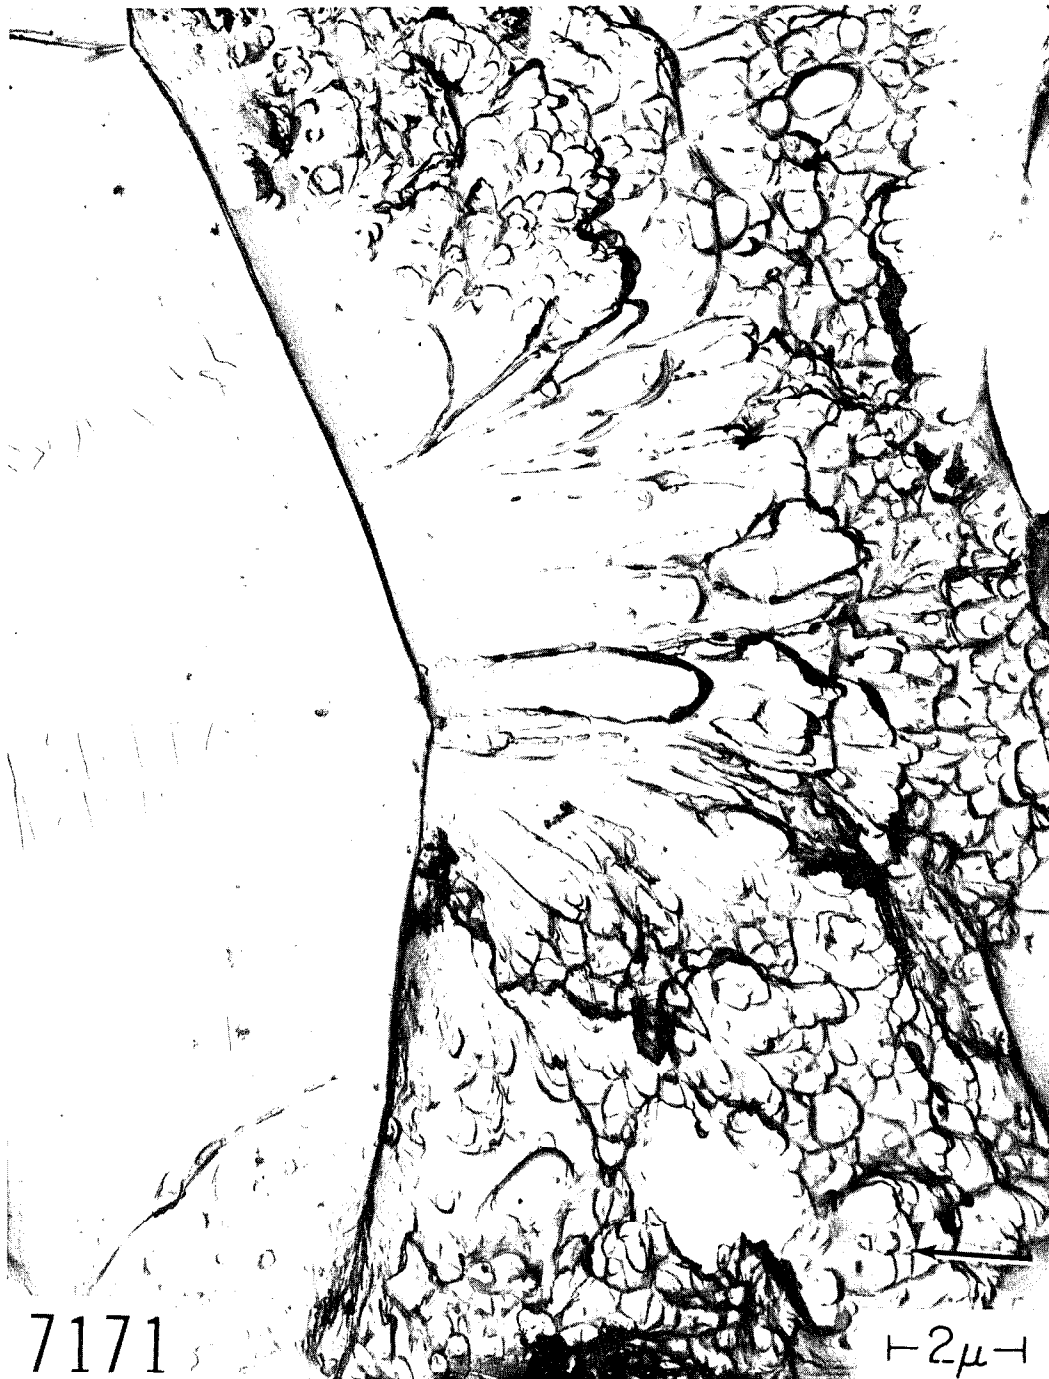
Fig. 44 - Tear dimples in plane-strain monotonic fracture surface of a 7075 T6 specimen which was broken at room temperature. Surface is matched with that shown in Fig. 45. Palladium shadowed direct carbon replica. 11,000X.

Precision matching studies showed that fracture occurred by void coalescence (Figs. 44-47), stretching (4) around broken intermetallic particles (Figs. 44-47), separation along boundaries between intermetallic particles and cleavage of intermetallic particles (Figs. 48-51), and a low deformation rupture process which is presently unidentified
